**CANADIAN FORCES
FLIGHT SAFETY INVESTIGATION (FSI)**

FINAL REPORT

FILE NUMBER: 1010-139308
DATE OF REPORT: 1 May 2003
AIRCRAFT TYPE: CH139 JET RANGER
DATE/TIME: 021712Z Jul 2002
LOCATION: Southport, MB
CATEGORY: "A" CATEGORY ACCIDENT

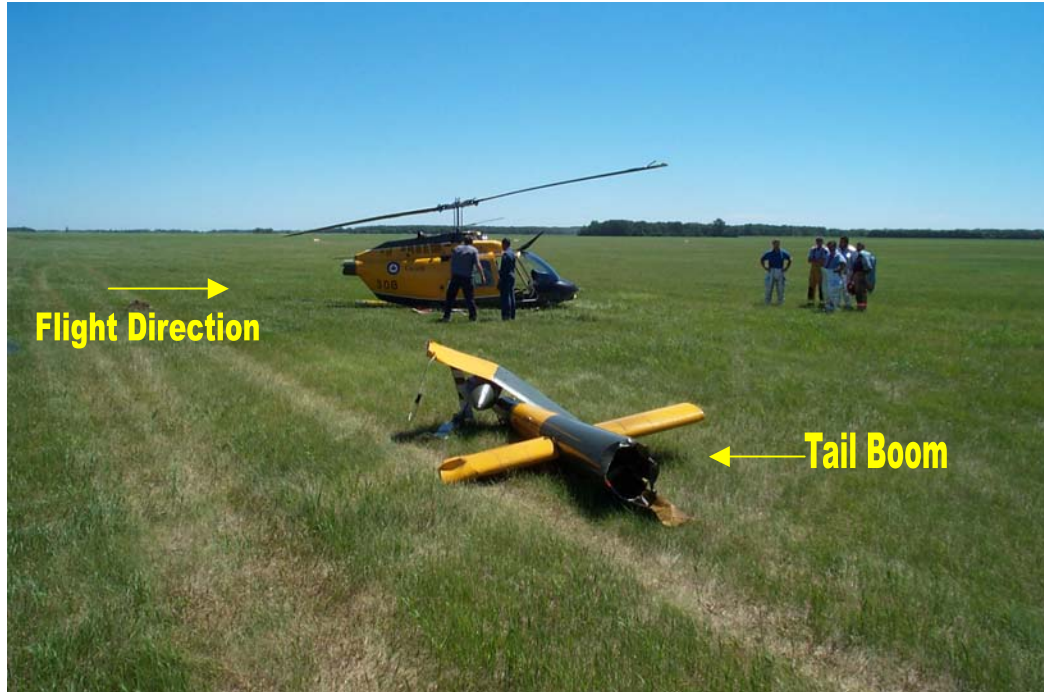
The skid gear completely collapsed causing the cross tubes to penetrate the floor structure and fuel tank (Photo 4). The tail boom was severed at the attachment point to the fuselage and came to rest approx 50 ft right of the main fuselage (Photo 1). The main rotor blades cut the vertical fin in two places as the tail boom departed the aircraft (Photo 6). One rotor blade was extensively damaged at the outboard tip due to contact with the vertical fin (Photo 5). The fuselage was considerably wrinkled on all sides due to impact forces. The plexiglass in the chin bubbles and windscreen was fractured due to flexing of the window frames (Photo 4). There was extensive gouging of the transmission fuselage housing due to contact with the pitch horns (flight control linkages to the main rotor). The forward end of the main drive shaft flexed downwards far enough to put a gouge through the drag link (component designed to dampen transmission movement). The transmission cooler mounted on the forward part of the transmission moved sufficiently left to gouge the support strut for the cyclic actuator (flight control that changes the tilt of the main rotor). The aircraft has been assessed as un-repairable ('A' Category damage).

Photo 1: Impact site - starboard side / Lieux d'impact - tribord

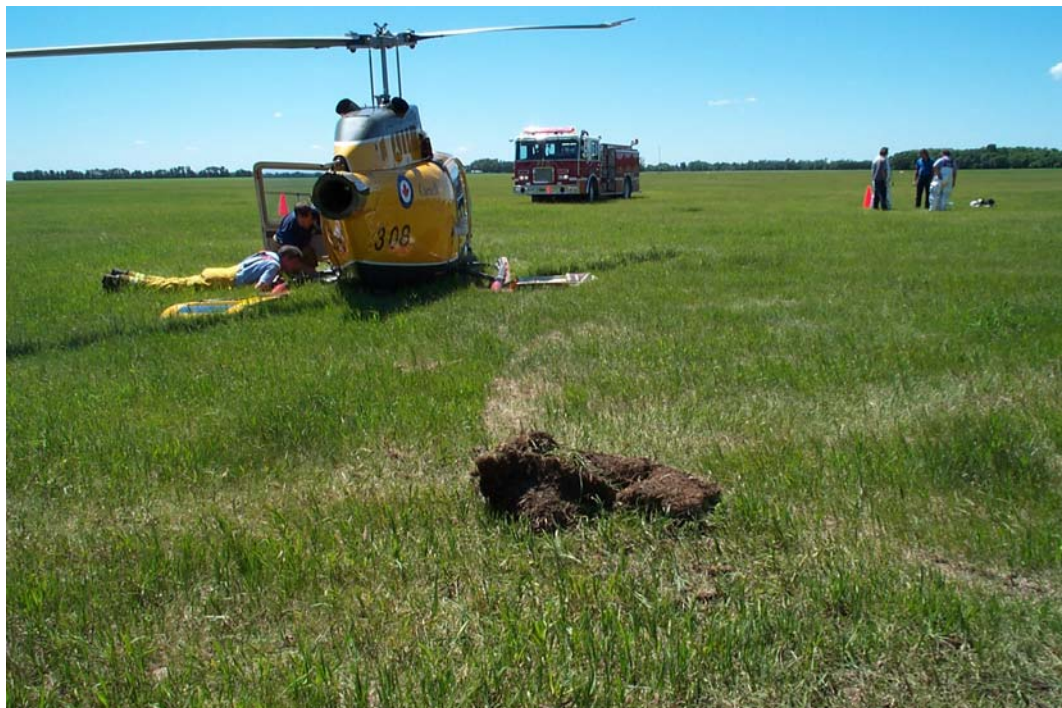
Photo 2: Wreckage – Rear View / Épave – Vue arrière

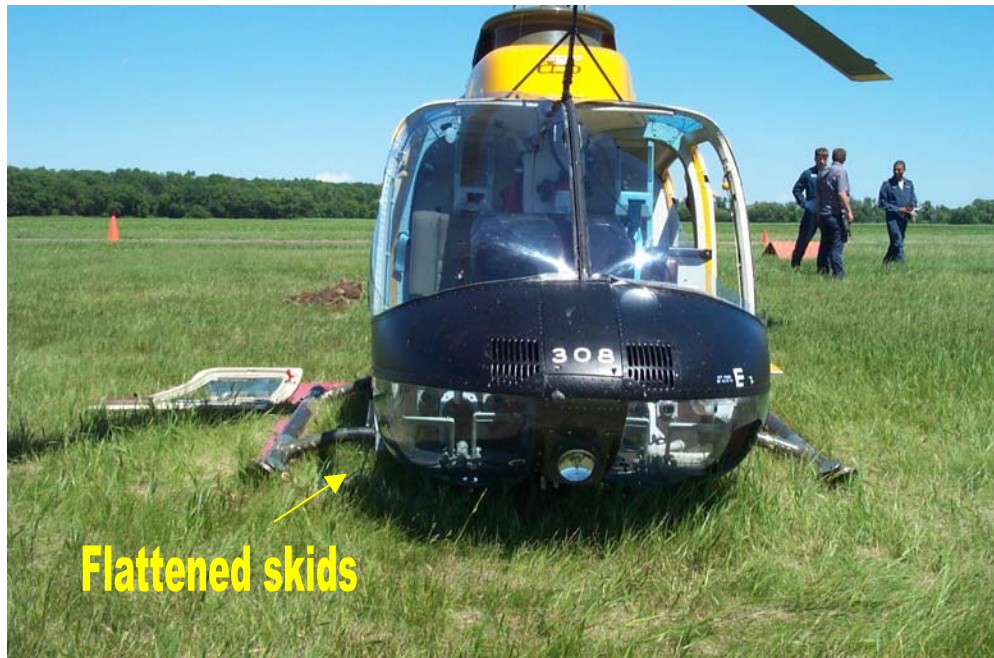
Photo 3: Wreckage – Front View / Épave – Vue avant

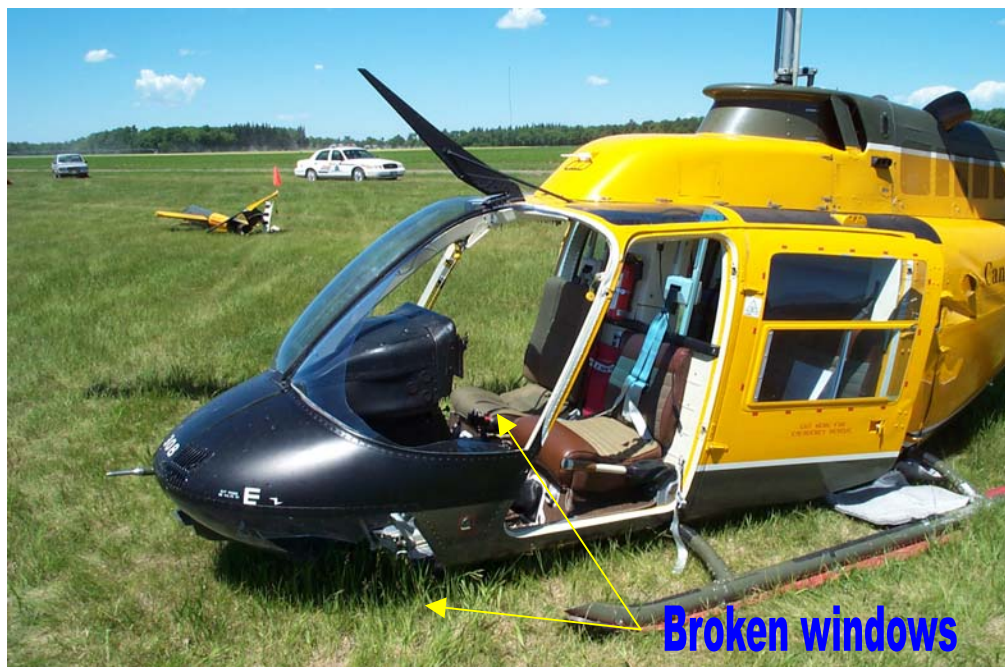
**Photo 4: Wreckage – Port Side View
(Doors removed by emergency crews)
Épave – Vue latérale gauche
(Portes retirées par les membres de l'équipe de secours)**

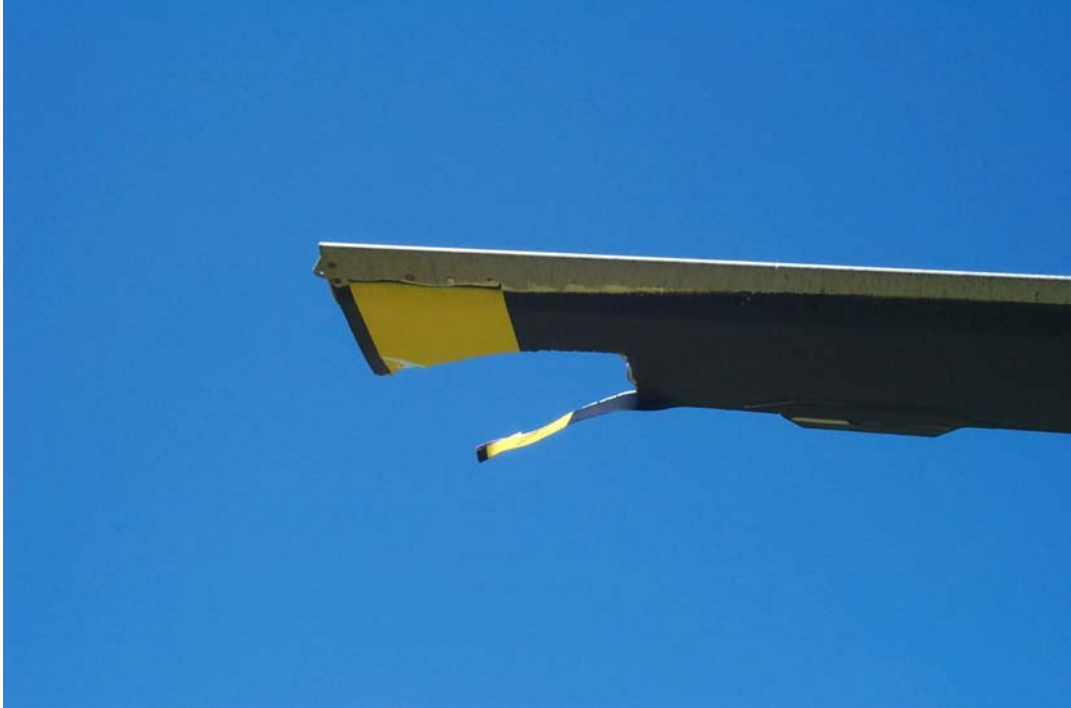
Photo 5: Main Rotor Blade – Damage from tail fin strike
Pale du rotor principal – Dommages dus à l'impact avec la dérive

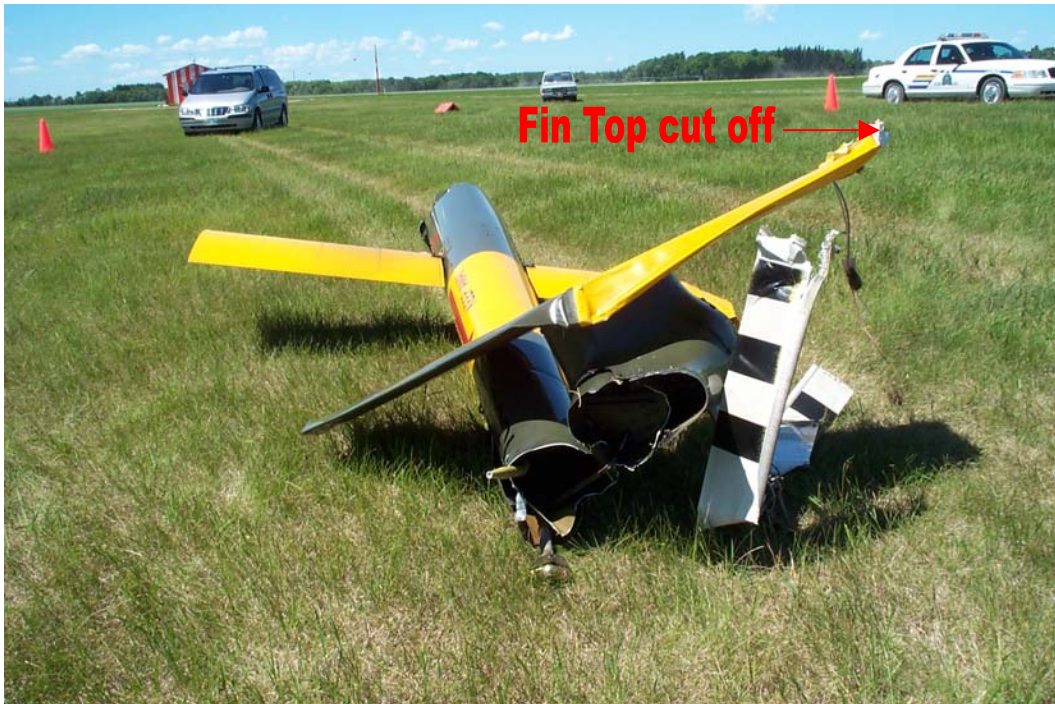
Photo 6: Tail Boom – Tail fin damage
Poutre de queue – Dommages subis par la dérive

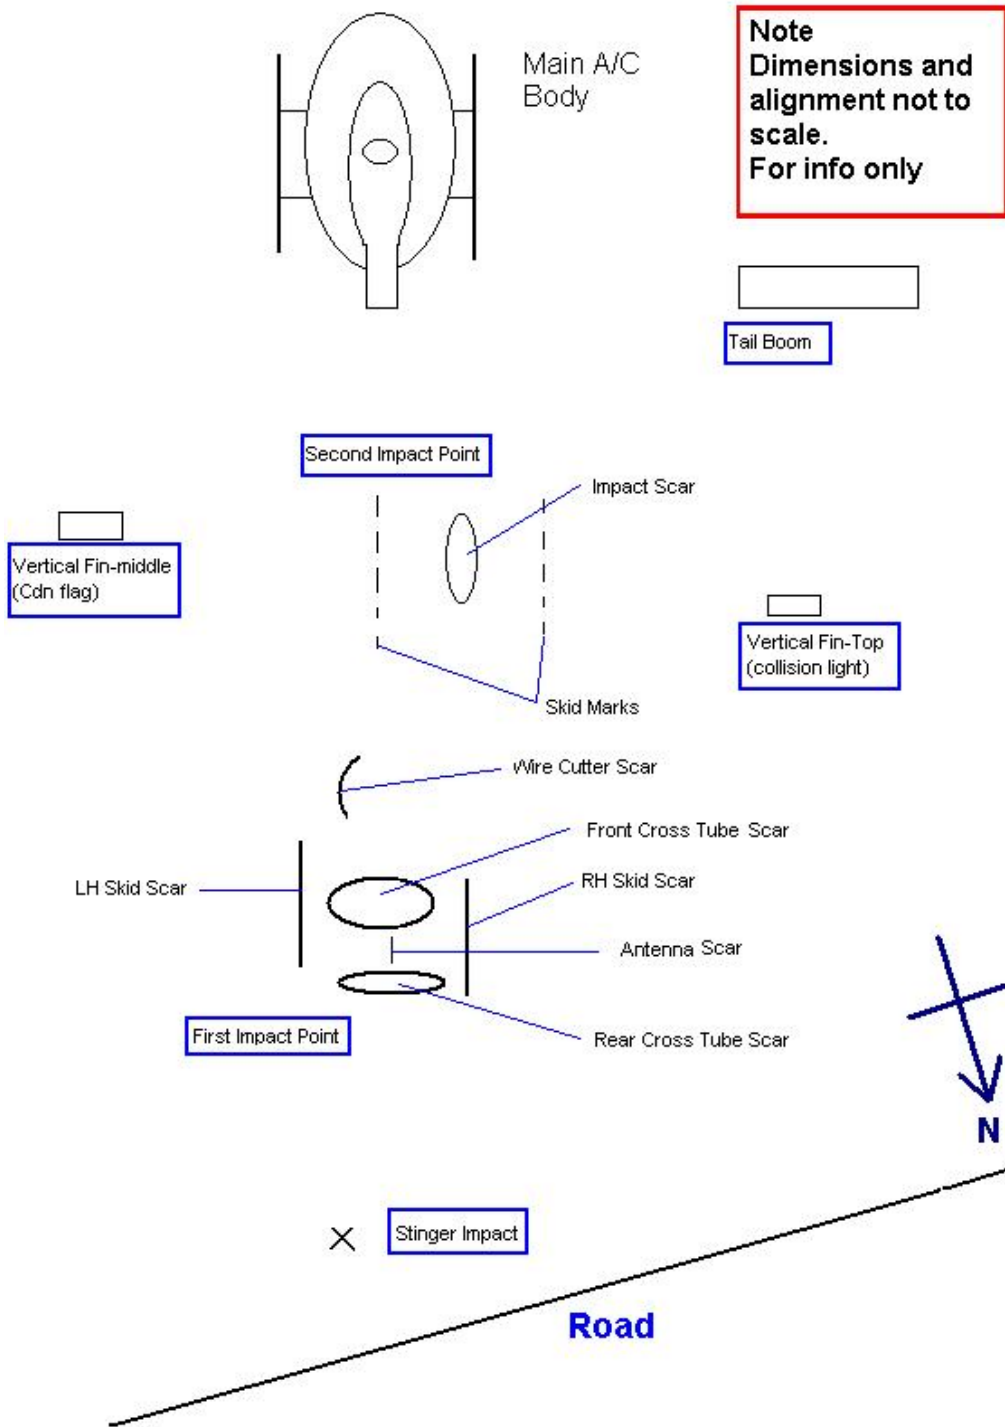
Annex B – Site Layout

The aircraft initially struck the ground just short of the marked landing area while heading approximately 240 degrees magnetic. It bounced back into the air, commenced spinning due to the loss of tail boom/tail rotor (anti torque thrust) and touched down again 50 feet from the initial impact point. It continued to spin several times on the ground and then came to rest in an upright manner 64 feet from the point of initial impact. The aircraft's final heading approximated the direction of the initial approach path (220 degrees). The tail boom broke off and came to rest 50 feet from the 3 o'clock position of the fuselage. Pieces of the tail fin ended up in the 5 o'clock position at 40 feet and 7 o'clock position at 42 feet (see Annex B for a site diagram).
